SACoMaTiS 2008

STRUCTURAL ASSESSMENT FOR TEMPORARY PROTECTION OF THE OLD MOSQUE IN SENKOVICI VILLAGE, BOSNIA AND HERZEGOVINA

Mustafa Humo (1), Salko Kulucija (2)

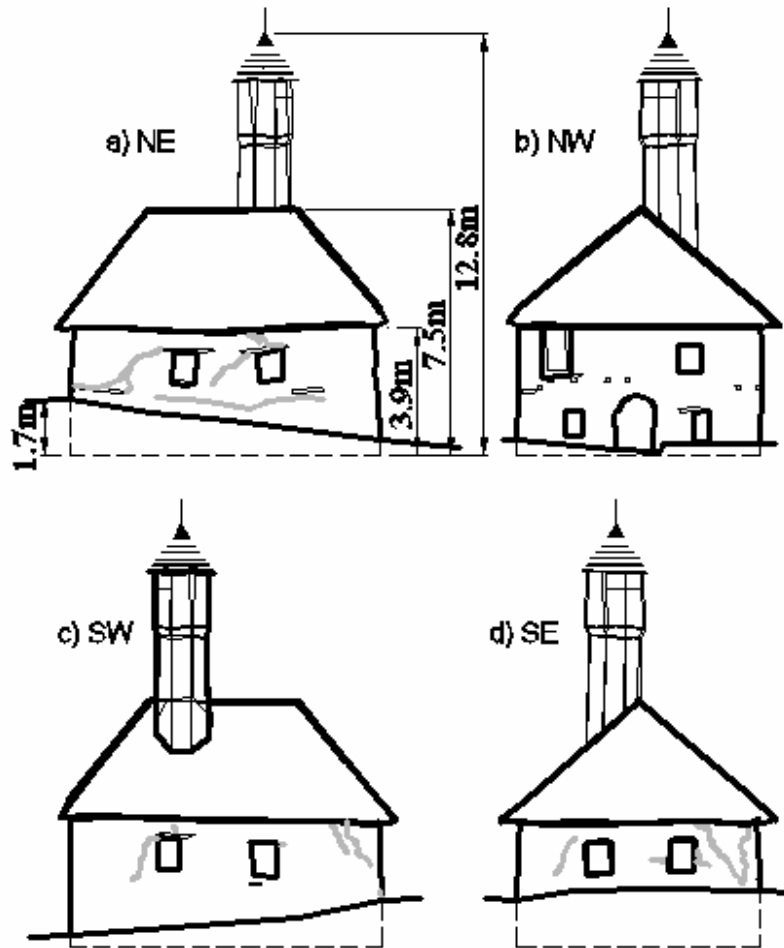
Crack pattern survey was done as indicated in grey in Figure 3.

Figure 3: Façade a) northeast, b) northwest, c) southwest and d) southeast; crack pattern marked in grey

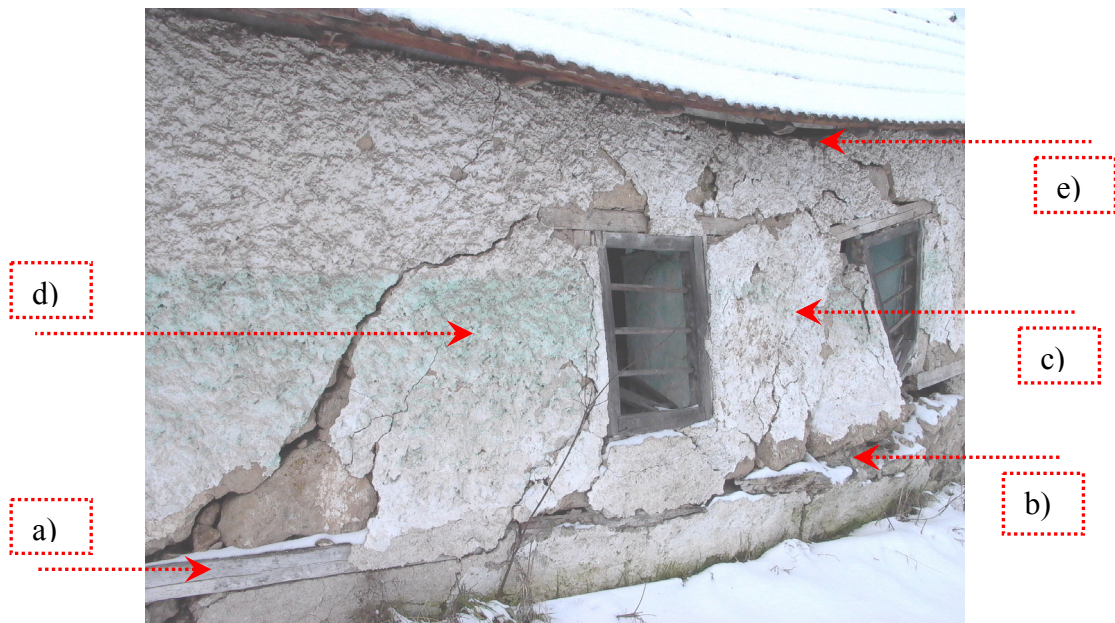
It was found that the major and the most critical damage is that on the northeast wall as indicated on Figures 4 to 7. The outer timber lacing is completely destroyed at approximately 1m length and the inner one is nearly totally decayed. Larger header blocks may be noticed and some of them overturned. Inner floor structure is partly supported by horizontal timber lacing.

Figure 4: Northeast façade, extract a) timber lacing (outer joist) at approx. mid height of the building, b) timber lacing missing outside and decayed inside, c) overturned masonry block assemblage between the windows, d) the next endangered masonry block assemblage, e) masonry settlement, top timber lacing and eaves deformed

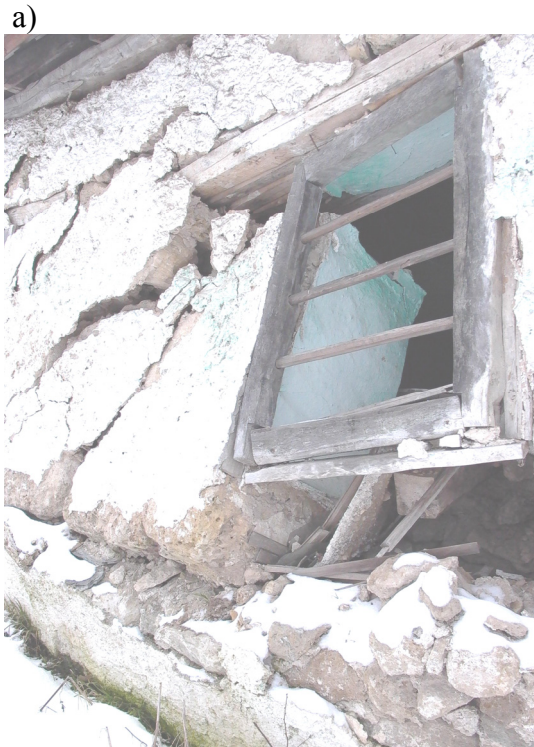
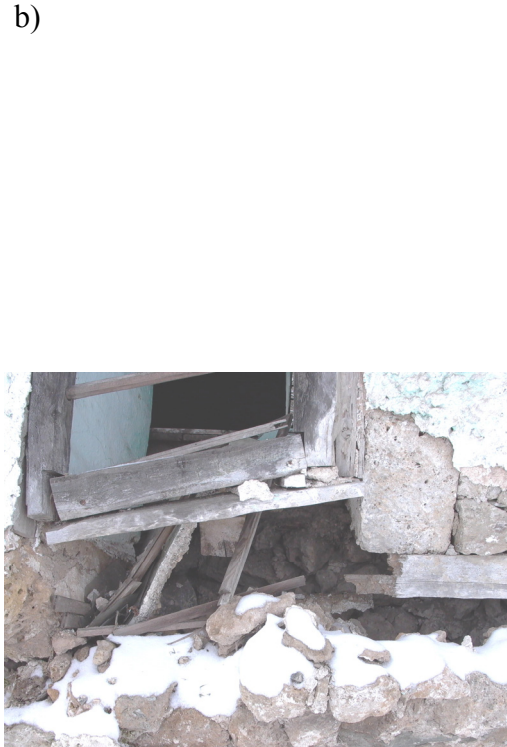
Figure 5: Northeast façade extracts a) scope of destruction at critical position, b) a closer look to the masonry and timber lacing

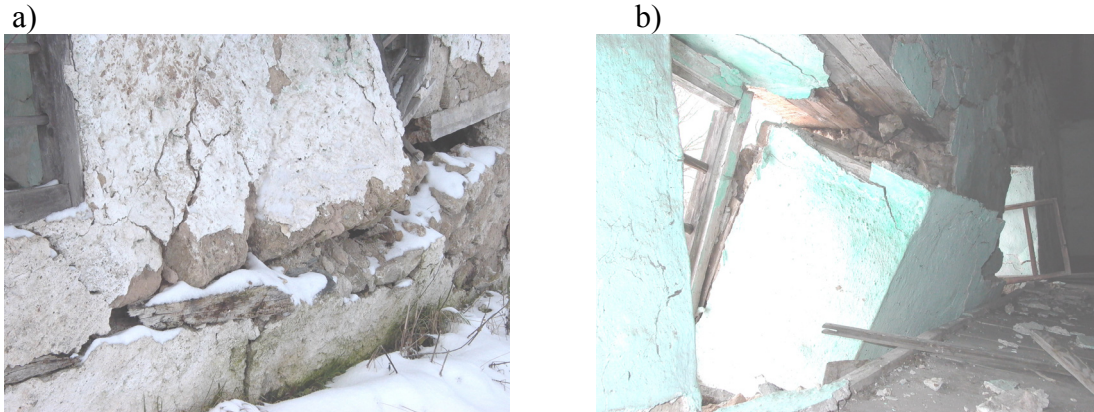
Figure 6: Northeast façade extracts a) total destruction of timber lacing followed by local masonry overturning, b) overturning viewed from inside

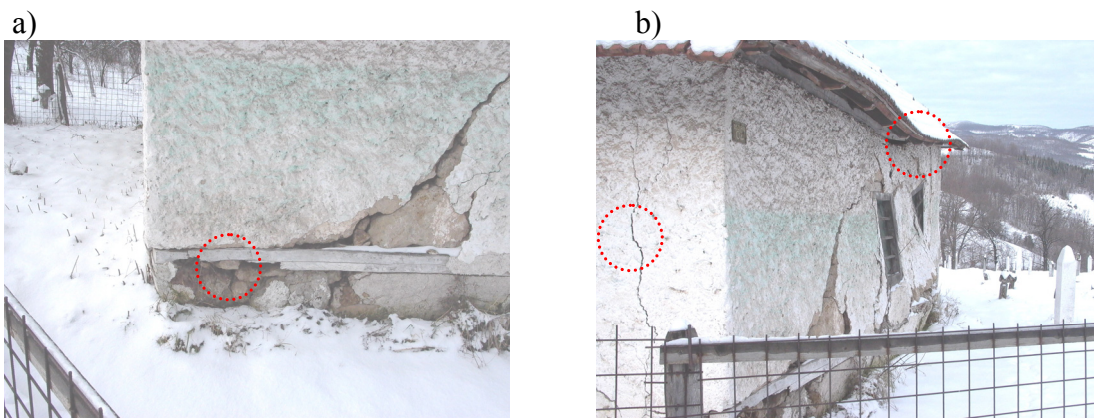
Figure 7: Northeast façade extracts a) further timber decay, b) structural cracking extended to the southeast façade, eaves deflection evident

- Cracks on southeast and southwest façade but without deformations of the wall itself; structural crack on southeast façade indicates propagation of timber decay.
- Significant moisture presence especially at parts below the ground level.
- Inner render evidently separated from the masonry.
- Outer render separation also noted
- Mortar in masonry joints of a poor quality. Very easy to be scratched out.
- Significant deflection of mahfil timber structure. No cracks visible.
- Bad quality and bad workmanship of the roof timber structure.
- Roof structural system should be checked during the next design stage.
- Minaret wooden cladding damaged or missing and thus enabling constant water penetration into the building
- Minaret structure support exposed and in need of careful examination during the next design stage

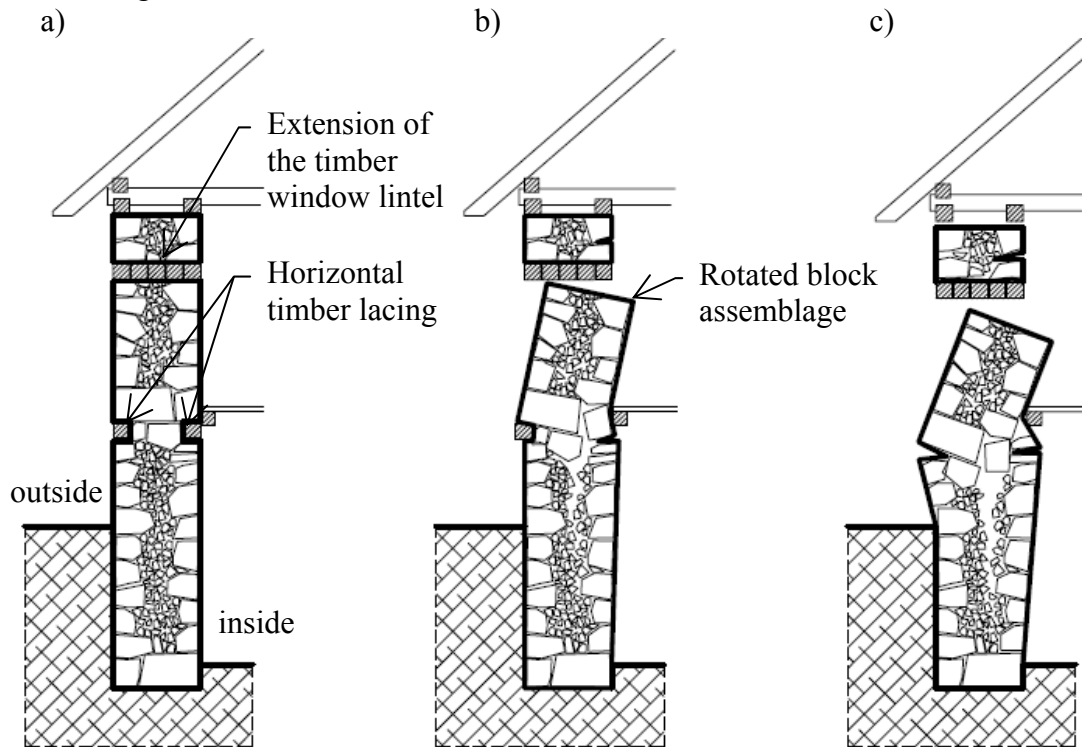
Development of the wall collapse mechanism was recognized as here schematically presented in Figure 8.

Figure 8: Vertical section through the northeast façade wall, next to the window jamb. Development of the collapse mechanism, a) undamaged stage, b) decay and destruction of the inner lacing caused initial overturning of the block assemblage between the lacing and the window lintel, c) local separation of masonry leaves, destruction of already decayed outer lacing, further rotation of the block assemblage and deflection of the window lintel were consequences of the new-formed loading scheme

- The major problem is overturning of masonry on the northeast façade, at present detected between the two windows but with clear evidence of further propagation. Decay and destruction of horizontal timber lacing, supporting larger header blocks caused the local collapse of the inner core of the multi-leaf wall underneath, leading then to overturning of the masonry above. The deformed masonry at this section is of approximately 120cm thickness compared to typical thickness of 80cm (Figure 2a). The top timber lacing, supporting the roof structure is significantly deformed at critical position as marked in Figure 7b. Propagation of this problem may be noticed (Figure 7a). Further collapse of masonry is thus expected, leading then to collapse of top timber lacing and breakdown of the roof and ceiling structure (possibly minaret as well). Urgent measures should be taken to prevent failure.
