## PRIRODNO-GRADITELJSKA CJELINA – MOST U PLANDIŠTU („RIMSKI“ MOST; MOST PREKO RIJEKE BOSNE U PLANDIŠTU)

### THE NATURAL AND ARCHITECTURAL ENSEMBLE OF THE BRIDGE IN PLANDIŠTE (THE “ROMAN” BRIDGE; THE BRIDGE OVER THE BOSNA IN PLANDIŠTE)

Most u Plandištu – program zaštite mosta

Općina Ilijadža, Sarajevo

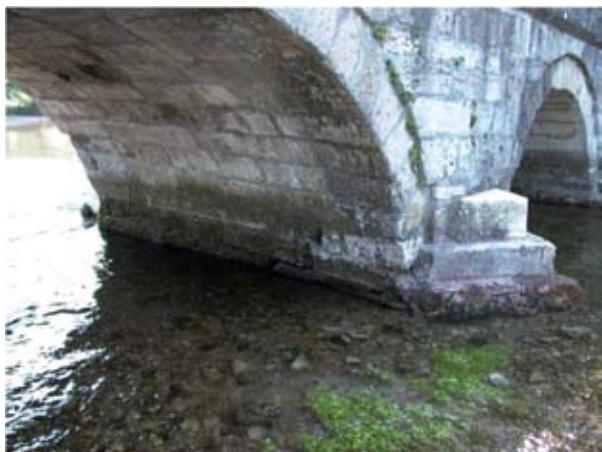
*Sl. 5 – Prikaz temelja i početka luka. Vidljivo karakteristična slaba popunjenošć spojnica u temeljima. Primijećena podlokanost temelja na više mesta.*

*Illus. 5 – View of the footings and base of the arches, showing typical erosion of the joints in the footings and undercutting of the footings in several places*

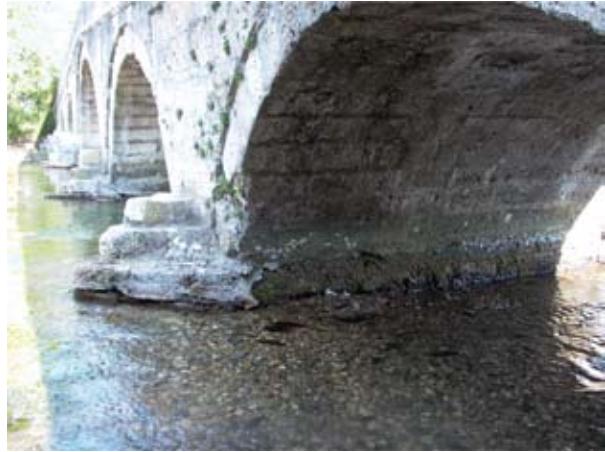
*Sl. 6 – Vidljivo karakteristično prisustvo mahovine i sitnog rastinja na temeljima, lukovima i čeonim zidovima.*

*Illus. 6 – View showing typical presence of moss and minor plant growth on the footings, arches and spandrel walls*

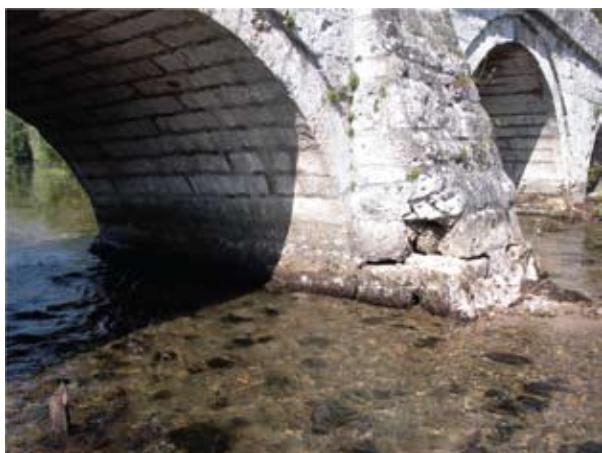
*Sl. 7 – Oštećenje dna kontrafora ispred stuba S3 na nizvodnoj strani. Primijećena značajna podlokanost i otvaranje spojnica na dijelu kontrafora.*

*Illus. 7 – Damage to the base of the buttress in front of pier S3 on the downstream side, showing significant undercutting and joints opening up on part of the buttress*

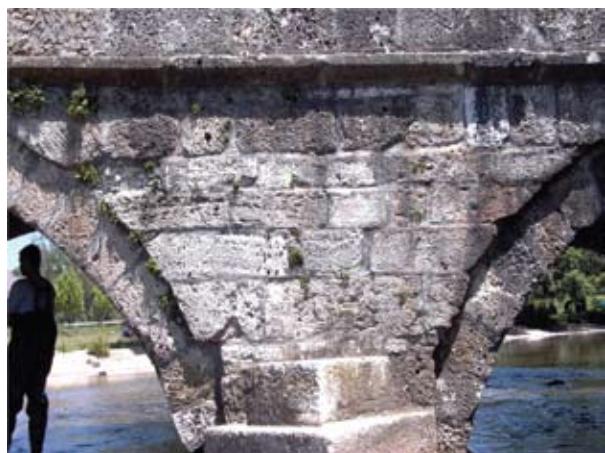
*Sl. 8 – Vidljiva karakteristična lokalna oštećenja blokova čeonog zida i to naročito oštećenja rubova na spoju sa lukom.*

*Illus. 8 – Showing typical local damage to the blocks of the spandrel wall, and in particular damage to the edges where they join the arch*

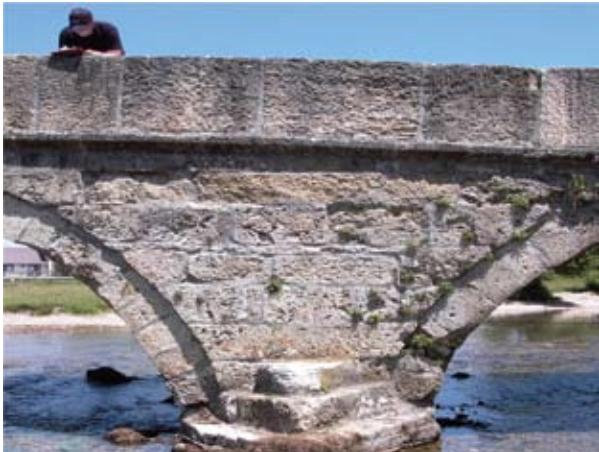
*Sl. 9 – Vidljiva karakteristična lokalna oštećenja kamenih blokova lukova  
Illus. 9 – Showing typical local damage to the stone blocks of the arches*

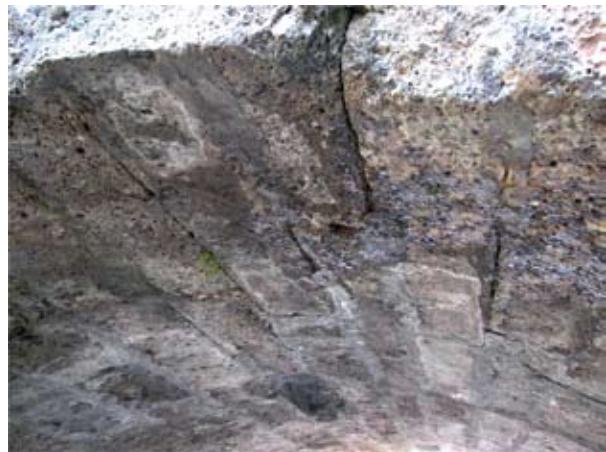
*Sl. 10 – U manjem obimu primijećeno otvaranje spojnica između blokova lukova  
Illus. 10 – Showing lesser instances of joints opening up between the blocks of the arches.*

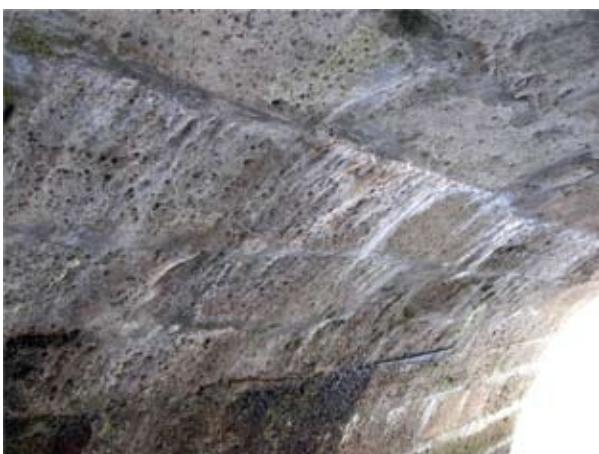
*Sl. 11 – U manjem obimu primijećeni tragovi procjeđivanja kroz spojnice lukova  
Illus. 11 – Showing lesser instances of traces of percolation through the joints of the arches*

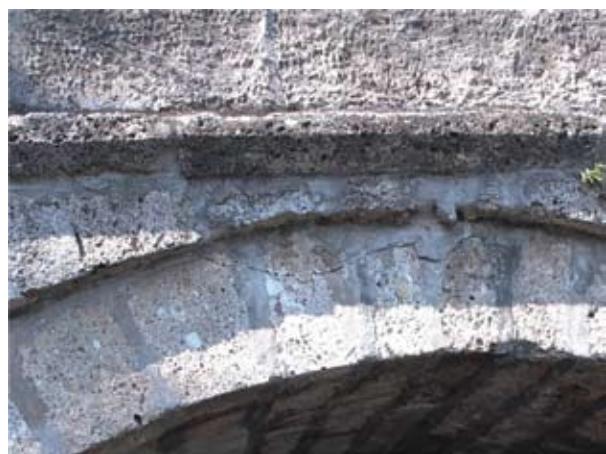
*Sl. 12 – U manjem obimu, na nizvodnoj strani, primijećene poduzne pukotine u tjemenu lukova  
Illus. 12 – Showing lesser instances on the downstream side of longitudinal cracks at the apex of the arches*
