PREGLED HISTORIJSKIH METODA TEMELJENJA

SURVEY OF HISTORIC FOUNDATION ENGINEERING

Salko KULUKČIJA
Mustafa HUMO

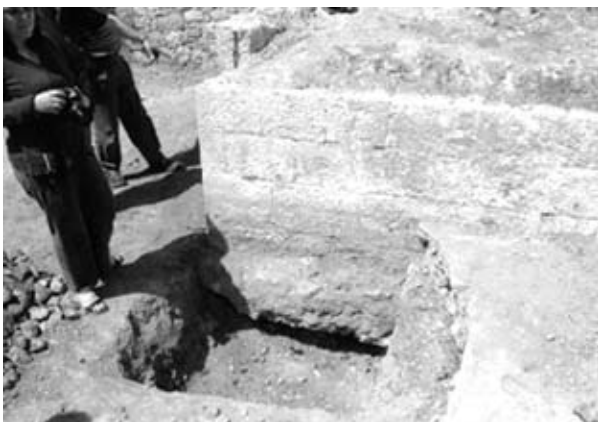
Sl. 1 - PDŽS, ostaci drvenog roštilja ispod temelja munare (Projekat rehabilitacije „Podgradska džamija u Stocu“)

Illus 1 - PMS, remains of timber grille below the foundations of the minaret (Rehabilitation project for the Podgradska mosque in Stolac)

Foundations built partly of timber were found to have been used for the minarets of two mosques in Stolac (the Podgradska, *illus. 1 and 2*, and Ćuprijska, *illus. 3 and 4*, mosques). Foundations built partly of timber are also to be found in the case of the old bridge in Konjic (*illus. 7 and 8*), the bridge over the Drina in Višegrad (*illus. 10*) and the bridge over the Neretva in Glavatičevo. This type of construction was still being used in the early 20th century, until finally displaced by reinforced concrete constructions.

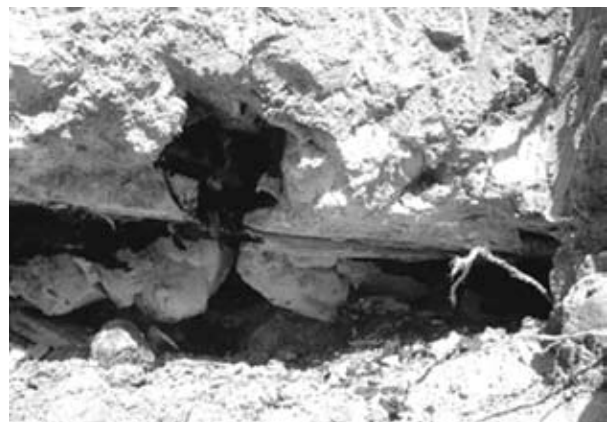
Sl. 2 - PDŽS, ostaci drvenog roštilja, uvećano (Projekat rehabilitacije „Podgradska džamija u Stocu“)

Illus 2 - PMS, remains of timber grille, enlarged (Rehabilitation project for the Podgradska mosque in Stolac)

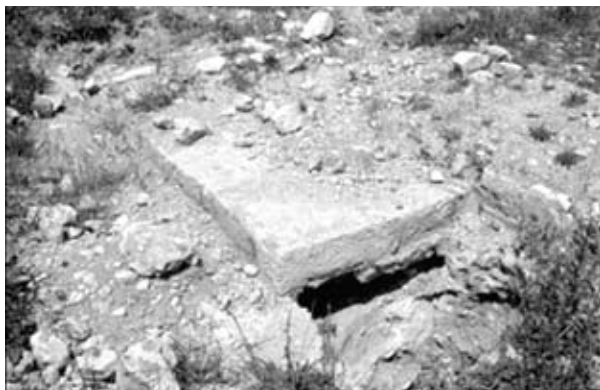
Sl. 3 - ĆDžS, ostaci drvenog roštilja ispod temelja munare (Projekat rehabilitacije „Ćuprijska džamija u Stocu“)

Illus. 3 - ĆMS, remains of timber grille below the foundations of the minaret (Rehabilitation project for the Ćuprijska mosque in Stolac)

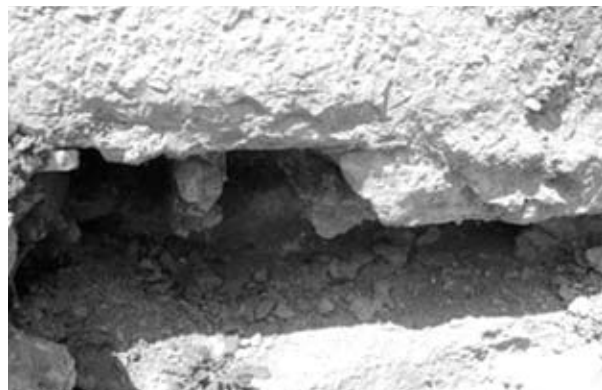
Sl. 4 - ĆDžS, ostaci drvenog roštilja, uvećano (Projekat rehabilitacije „Ćuprijska džamija u Stocu“)

Illus. 4 - ĆMS, remains of timber grille, enlarged (Rehabilitation project for the Ćuprijska mosque in Stolac)

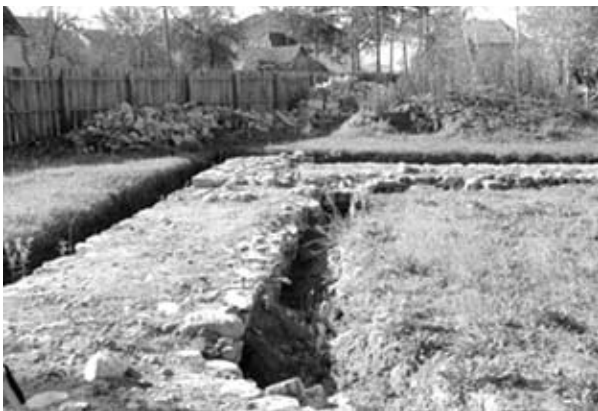
Sl. 5 - ADŽBP, trakasti temelji na jugoistočnoj strani (Projekat rehabilitacije „Azizija džamija u Brezovom Polju“)

Illus. 5 - AMBP, strip footings, south-east side (Rehabilitation project for the Azizija mosque in Brezovo Polje)

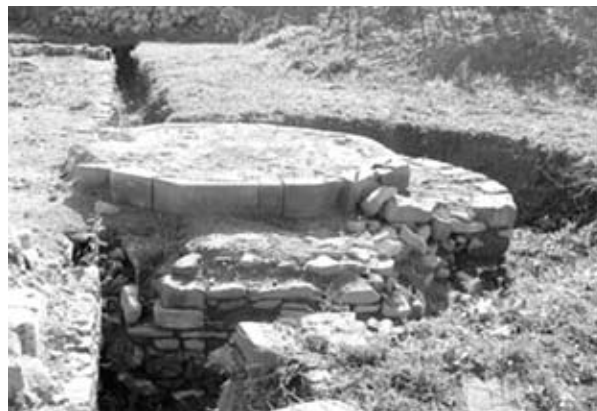
Sl. 6 - ADŽBP, ostaci temelja munare (Projekat rehabilitacije „Azizija džamija u Brezovom Polju“)

Illus. 6 - AMBP, remains of minaret foundations (Rehabilitation project for the Azizija mosque in Brezovo Polje)

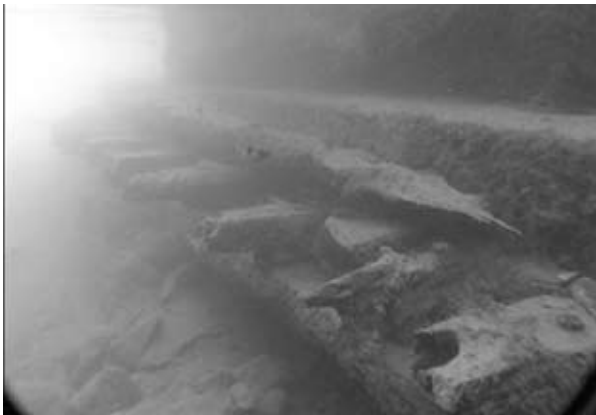
Sl. 7 - SMK, podvodni snimak stanja drvenog roštilja (Projekat istražnih radova i izvođenje istražnih radova „Stari most u Konjicu“)

Illus 7 - OBK, underwater view of condition of timber grille (Project for investigative works and execution of investigative works on the old bridge in Konjic)

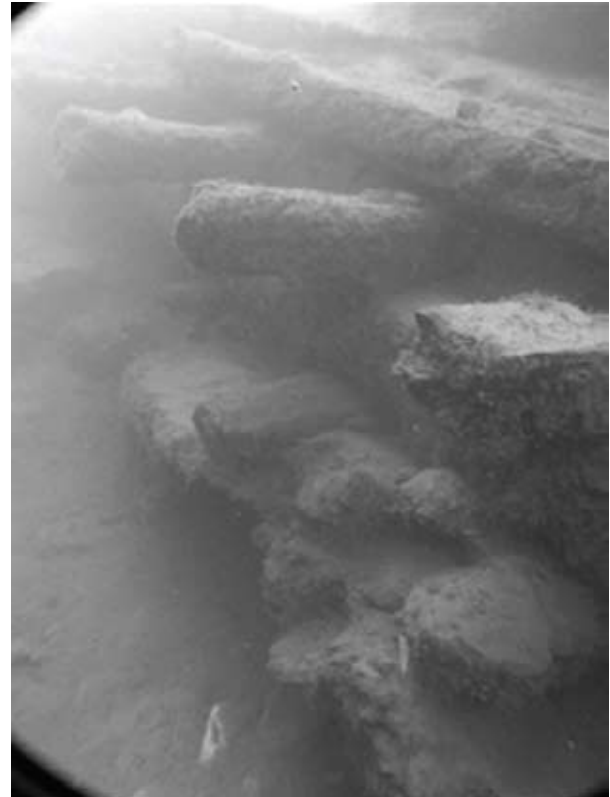
Sl. 8 - SMK, podvodni snimak stanja drvenog roštilja, uvećano (Projekat istražnih radova i izvođenje istražnih radova „Stari most u Konjicu“)

Illus. 8 - OBK, underwater view of state of timber grille, enlarged (Project for investigative works and execution of investigative works on the old bridge in Konjic)
