SACoMaTiS 2008

STRUCTURAL ASSESSMENT FOR TEMPORARY PROTECTION OF THE OLD MOSQUE IN SENKOVICI VILLAGE, BOSNIA AND HERZEGOVINA

Mustafa Humo (1), Salko Kulucija (2)

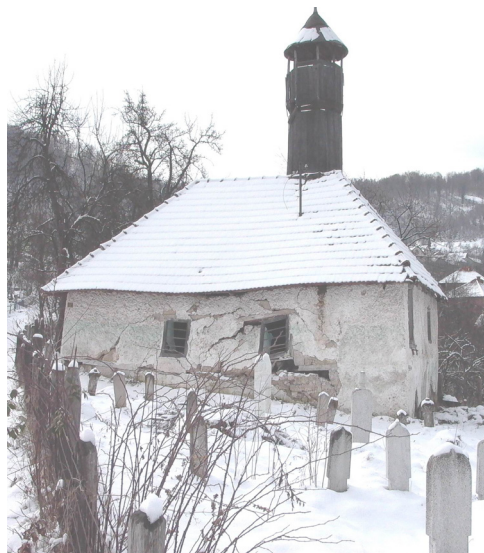
Figure 1: The Old mosque in Senkovici village, northeast view

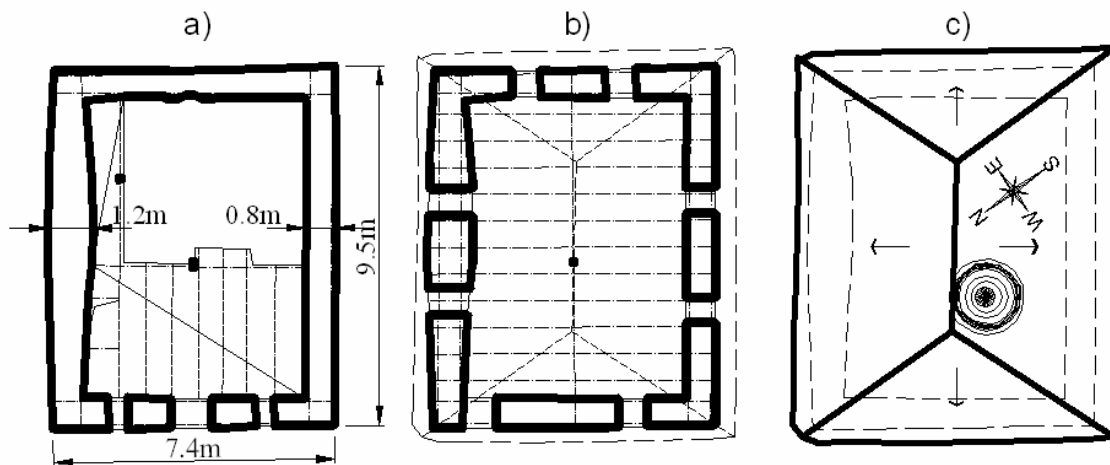
Figure 2 : a) ground floor level with mahfil structure above, b) mahfil floor level with timber ceiling structure above, c) roof plan
