## PRIRODNO-GRADITELJSKA CJELINA – MOST U PLANDIŠTU („RIMSKI“ MOST; MOST PREKO RIJEKE BOSNE U PLANDIŠTU)

### THE NATURAL AND ARCHITECTURAL ENSEMBLE OF THE BRIDGE IN PLANDIŠTE (THE “ROMAN” BRIDGE; THE BRIDGE OVER THE BOSNA IN PLANDIŠTE)

Most u Plandištu – program zaštite mosta

Općina Ilijadža, Sarajevo

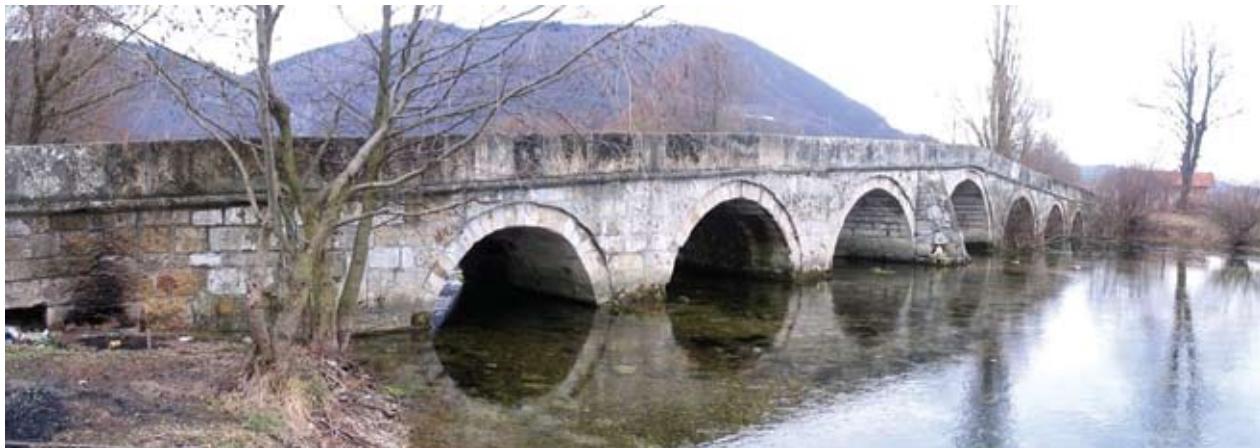
Sl. 1 – Fotografije mosta iz 2005. godine, nizvodna fasada

Illus. 1 – Photographs of the bridge in 2005 , downstream facade

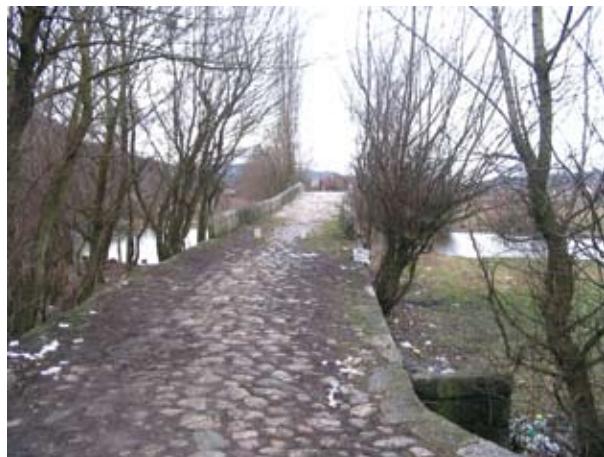
*Sl. 3 – Popločanje  
Illus. 3 – Paving*

Since 1986, minor damage has been caused to the bridge and its roadway: considerable damage to the paved surface caused by weathering and the roots of plants that have sown themselves in the joints and on the surface of the paving and in the spandrel walls; the stone is dirty from weathering; and there is minor physical damage to stone blocks.

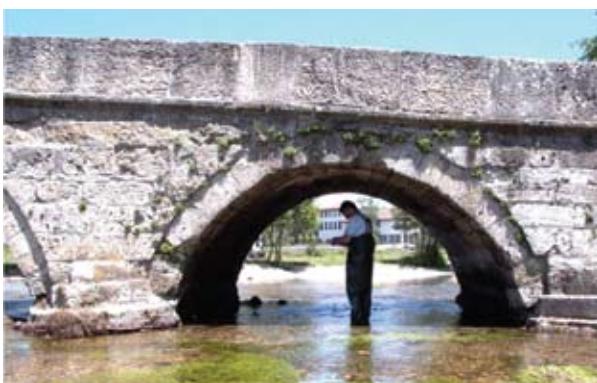
Sl. 2 – Pogled sa uzvodne strane. S desna na lijevo: stub S1, luk L2, stub S2. Jasno vidljiva proporcija u odnosu na čovjeka.

Illus. 2 – View from upstream. Right to left: pier S1, arch L2, pier S2, clearly showing the proportions in relation to the human scale.

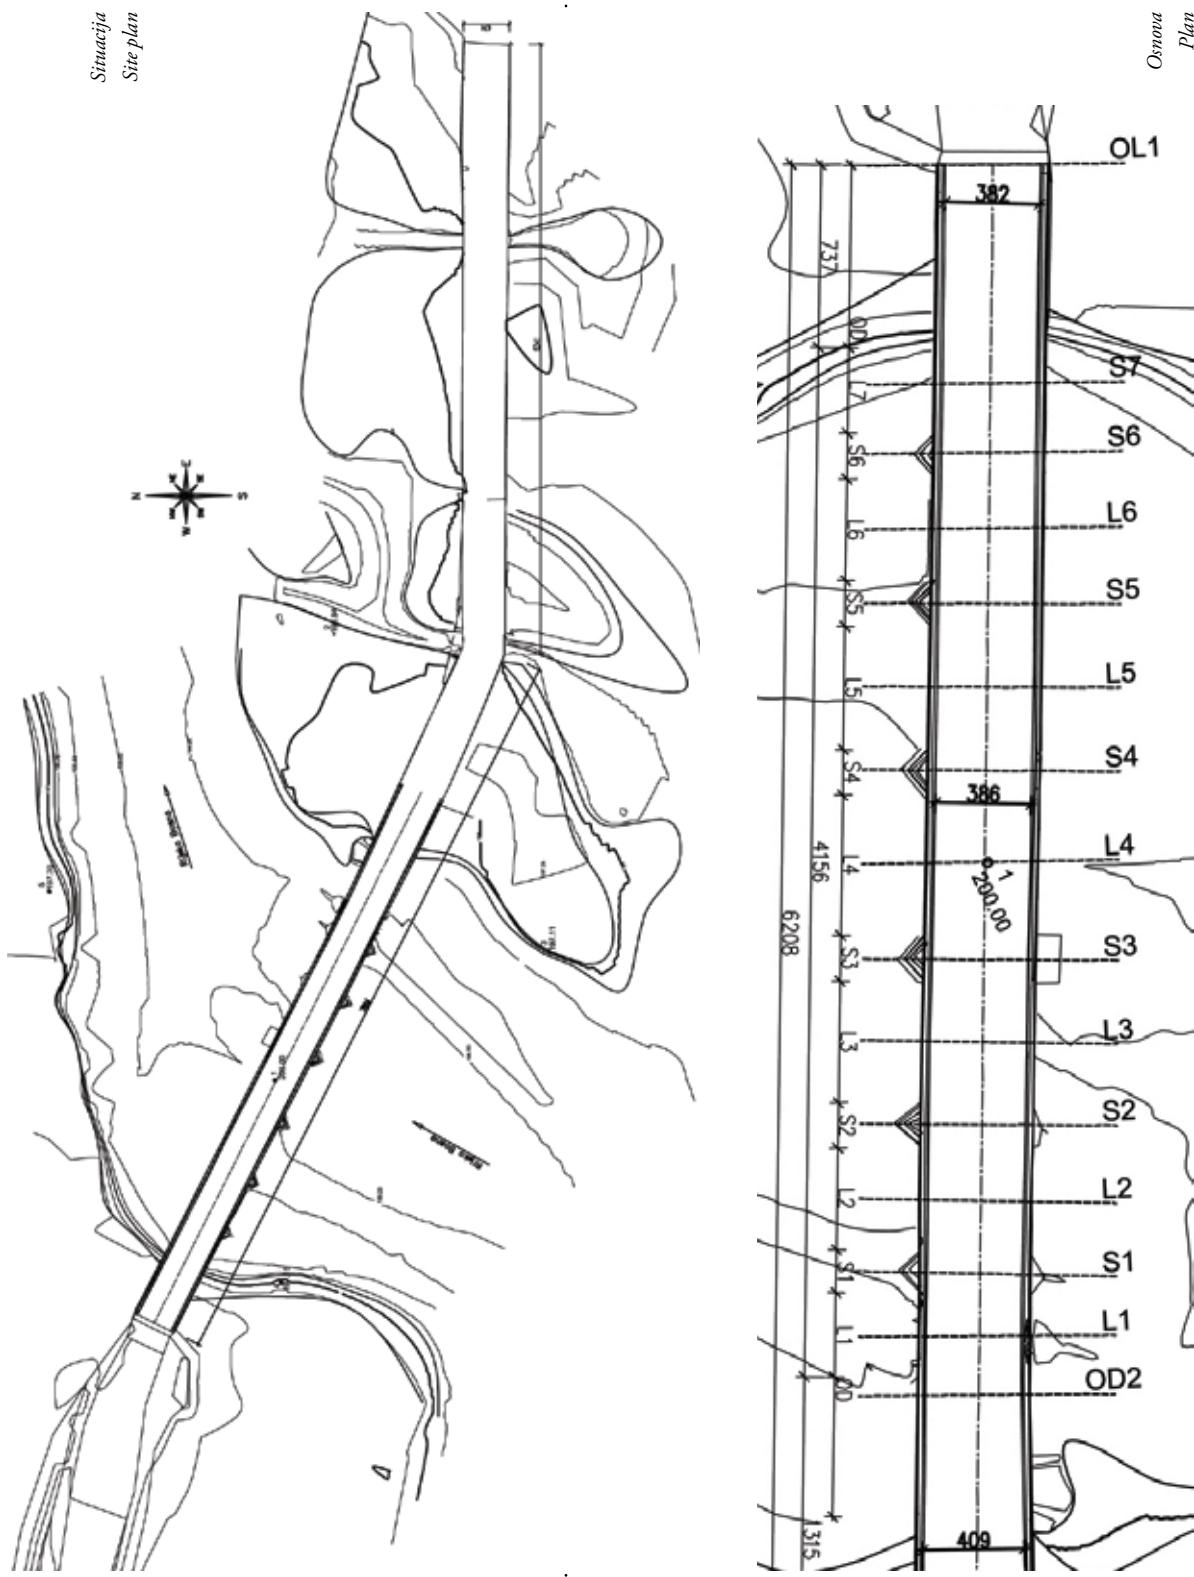
Sl. 3 – Snimak postojecog stanja mosta  
Illus. 3 – Architecture survey of the condition of the bridge

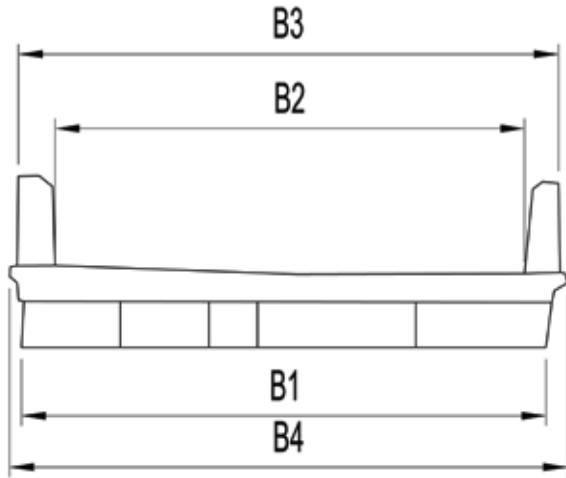
Sl. 4 – Karakterističan poprečni presjek mosta sa prikazom širina B1 do B4 navedenih u Tabeli 3.

Illus. 4 – Typical cross-section of the bridge showing width B1 to B4 as given in Table 3

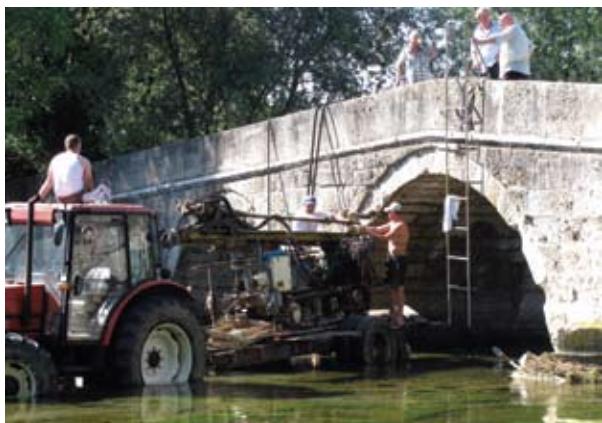
Sl. 13 – Geotehničko bušenje u području temelja

Illus. 13 – Geotechnical drilling in the area of the footings

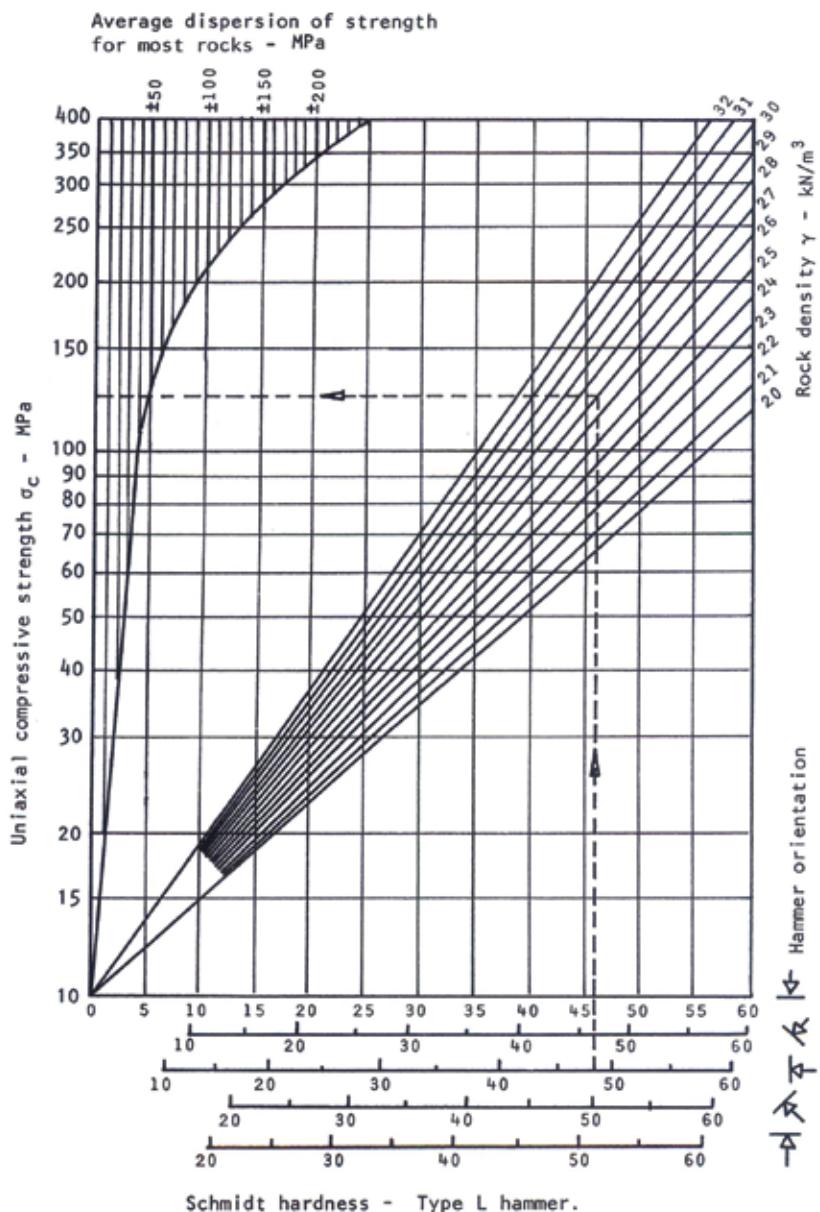
The uniaxial compressive strength of the stone blocks tested by Schmidt hammer was estimated using the diagram (fig. 2). Comparisons between the resistance calculated in the laboratory with that estimated using the Schmidt hammer test revealed a good degree of correlation.

$\sigma_c$  is given by the graph as  $125 \pm 50$  MPa. Note that the hammer should always be perpendicular to the rock surface.

Relationship between Schmidt hardness and the uniaxial compressive strength of rock, after Deere and Miller<sup>100</sup>.
